HARRY DIAMOND LABS ADELPHI MD  
STRUCTURAL FIRING TESTS OF THE M735 PROXIMITY FUZE.(U)  
MAY 79 J M MILLER, S A BORING  
HDL-TM-79-6

REPORT DOCUMENTATION PAGE		READ INSTRUCTIONS BEFORE COMPLETING FORM
1. REPORT NUMBER HDL-TM-79-6	2. GOVT ACCESSION NO.	3. RECIPIENT'S CATALOG NUMBER
4. TITLE (and Subtitle) Structural Firing Tests of the M735 Proximity Fuze		5. TYPE OF REPORT & PERIOD COVERED Technical Memorandum

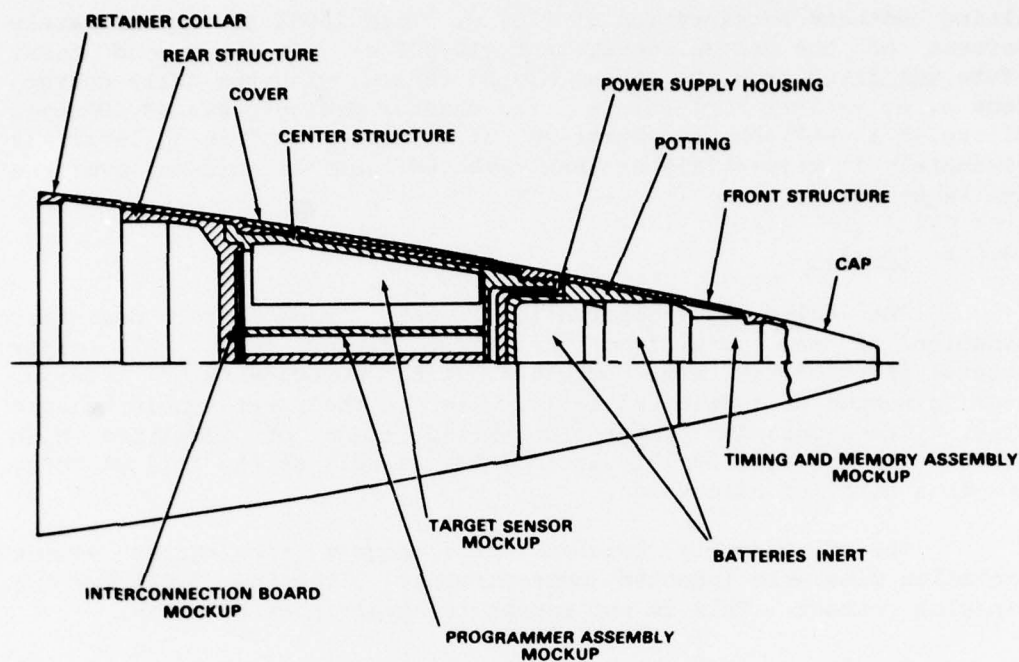
Figure 7. Structural mockup fuze, Group 1.

The following observations were made after post-test examination of the fuze from the first firing test. All major structural parts of the fuze survived, with no evidence of yielding. However, a number of fasteners failed, as did the power supply housing potting. The programmer boards also showed signs of localized high stresses. The observed individual failures as well as the failure modes follow in a detailed discussion.

The four screws which attach the target sensor assemblies to the center structure failed in shear. This failure was attributed to the potential differential axial deflection of the rf housings and center structure. In particular, the thin-walled center structure is not nearly as stiff as the rf housings in the axial direction. In addition, this structure must support a much larger inertial load, including the total mass of the nose section. As a result, the center structure axial strain rate is larger than that of the rf housings, thereby causing relative motion of the center structure with respect to the rf housings at gun launch. If the rf mounting screw clearance holes in the center structure are not large enough to accommodate this motion, the screw can fail.

The set screws which provide lateral support to the center of the programmer assembly failed (one was fractured and one was severely bent). This failure was attributed to the potential differential deflection of the rf housings and rear assembly, in particular the rear structure. Since the rear structure is inherently more compliant and more heavily loaded than the rf housings, the interface between the set screw and programmer assembly must be able to accommodate relative axial motion. If this interface does not provide a relatively smooth surface, the set screw can be pulled down by the rear assembly, thus resulting in screw failure. In this instance the set screws were prevented from moving by the protrusion of the tie bolt on the programmer assembly.

The forward assembly potting fractured at the forward lip of the power supply housing. This failure was apparently caused by the lack of adequate structural support for that portion of the potting which extended above the housing lip.

The two tie bolts which fasten the programmer assembly to the mounting blocks failed: both were severely bent and one was fractured. Due to the nature of the failure, and the fact that these bolts are not under load during setback acceleration, the failure was attributed to compression release acceleration. This acceleration results when the projectile's axial acceleration is suddenly unloaded at muzzle exit. This sudden load release produces a rebound effect which essentially results in a tensile wave traveling through the projectile. In this instance, the programmer boards are driven forward with respect to the rear structure. Relative motion of the board with respect to the rear structure is restrained by the tie bolts. In addition, the rear structure rebounds forward at its center, resulting in a slap to the bottom of the programmer boards which also loads the tie bolts. It was apparent from this failure that the tie bolts were not adequate.

The programmer boards exhibited localized delamination and thread engraving on the upper surface of the mounting holes. This damage also appeared to have been caused by compression release acceleration. The programmer boards also exhibited very slight localized delamination in the foot area. This localized failure was caused by setback acceleration loading, which produces highly localized stress in this area of the board. In particular, the programmer board support in this area was marginal due to cut-outs of the interconnect board in the mounting block area.

- The programmer center tie bolt was replaced with a threaded stud and nuts. The threaded stud length was such that it did not protrude beyond the outer surface of the nuts. The nuts provide a relatively smooth flat surface for the lateral support set screws, thus allowing axial movement of the programmer assembly nut with respect to the stud and preventing set screw failure.

- The power supply housing potting extension above the forward lip was eliminated to prevent potting failure.

- The programmer/mounting block tie bolts were replaced with high strength studs to prevent stud failure and programmer board delamination/engraving.

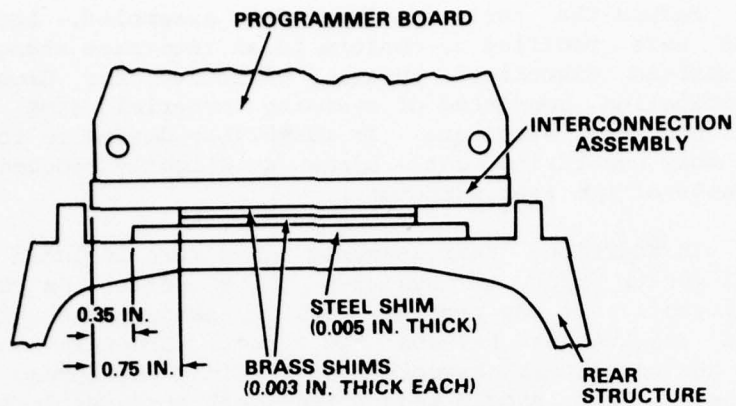
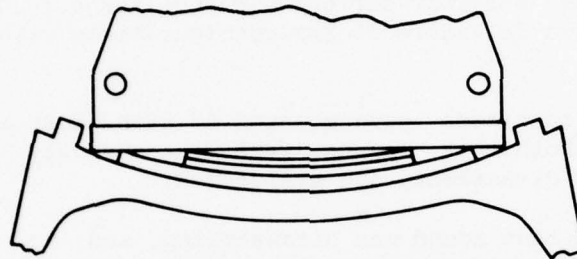
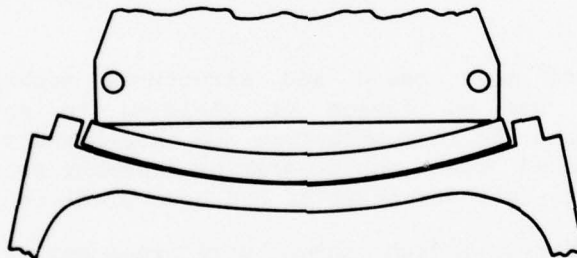
The second test round and structural mockup fuzes were disassembled. There was no damage or yielding to any fuze part. Markings found on both the rear structure and interconnect boards along the shim edges indicated that the programmer assembly support reaction was transmitted to the rear structure as had been predicted.
